UNITED STATES ENVIRONMENTAL PROTECTION AGENCY

SUBJECT: Emergency Removal at Dugan and Helterbrand Company,
Marshfield, Missouri

HAZARDOUS WASTE AND STORAGE INSPECTION AT D&H SILVER
RECOVERY 190 GEORGE ST. MARSHFIELD, MO.

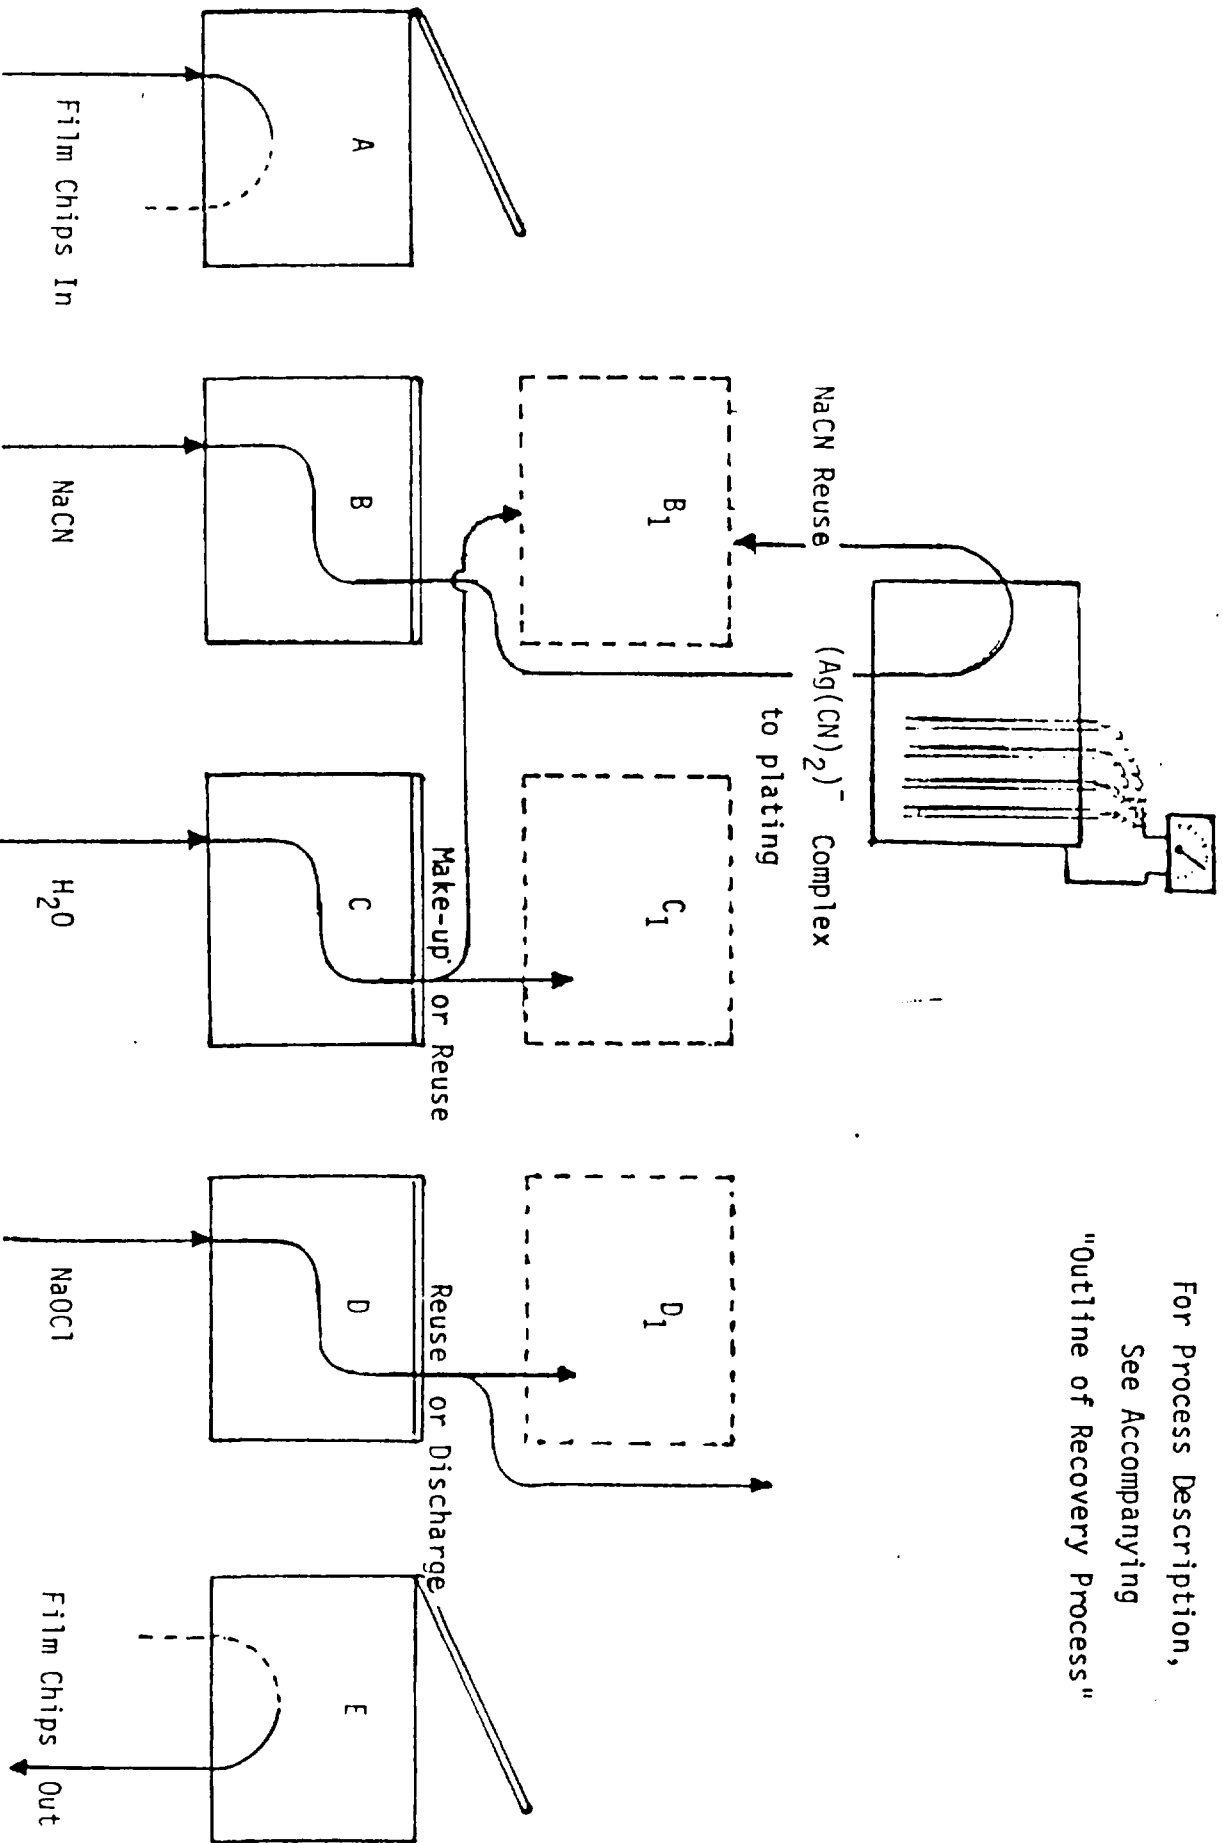
FLOWSHEET, depicting the flow of waste throughout the process
 Re: 10 CSR 25-9.010(1)(C)2.A.
 Page 2 of 2 pages.

For Process Description,
 See Accompanying
 "Outline of Recovery Process"

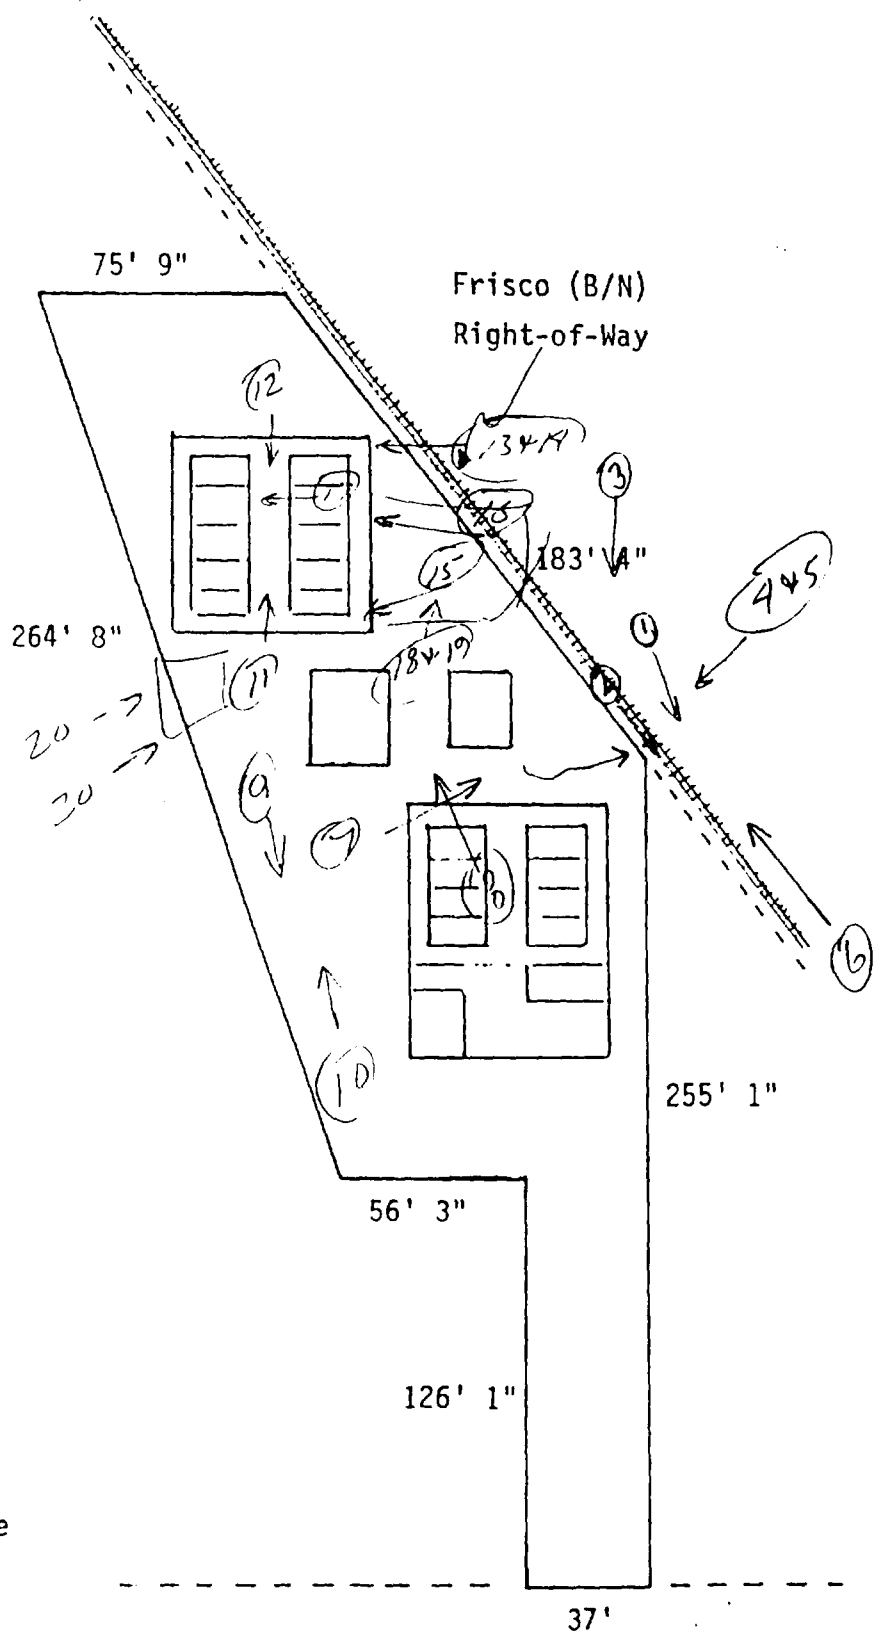
DETAIL OF PROPERTY

**SITE MAP IS
NOT ACCURATE**

SCALE 1" = 60'

Location of Buildings Approximate

George Street Right-of-Way

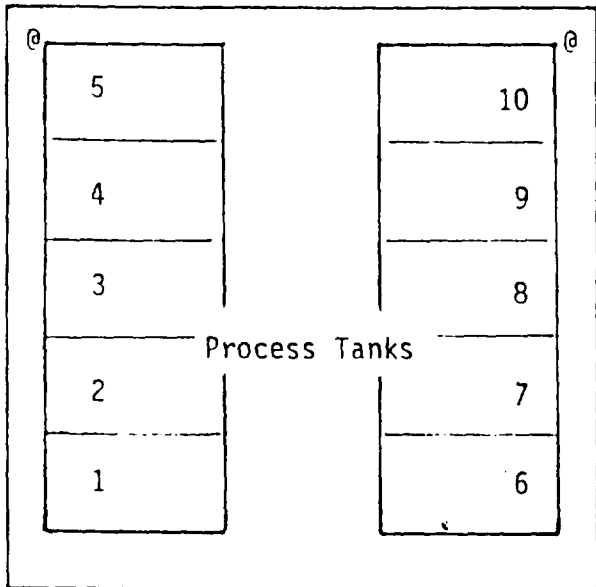
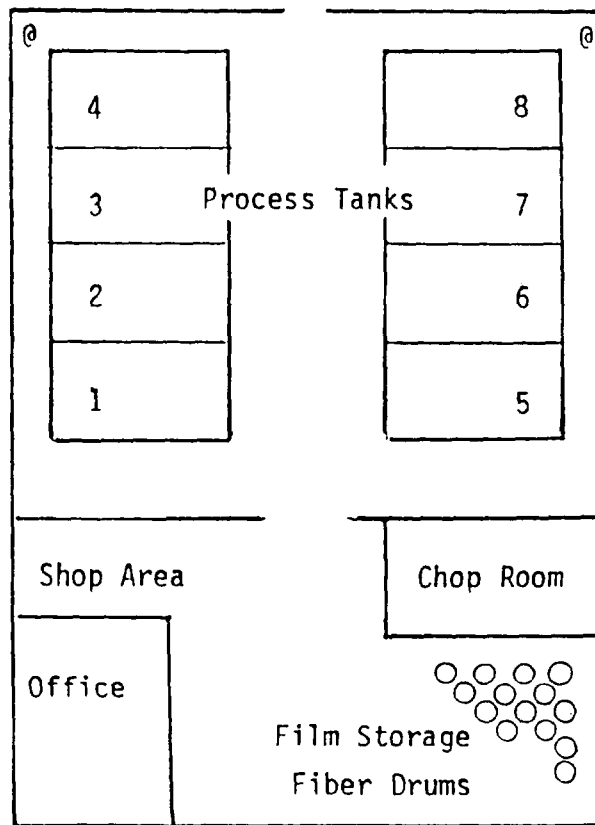
DETAIL OF BUILDINGS

East Process
Building

@ Location of Sump Pumps
(2 Each Process Building)
Discharge to Empty Tank(s)

West Process
Building
and Office

SCALE 1" = 20'
Locations and Dimensions
of Buildings Approximate
